MTA

Pre Purchase Inspection

Reference: RB 60521 **Examiners ID:** MM
Date: 18/01/2009
Time: 14.30
Inspection Type: Mobile Inspection \$244.00 inc GST

Make: Hyundai **Registration:** xxx 000
Year: 1999 **Vin#:** xxxxxxxx1234TY
Model: XL **Registration Date:** XX/XX/09
Colour: Blue **Odometer:** 132307

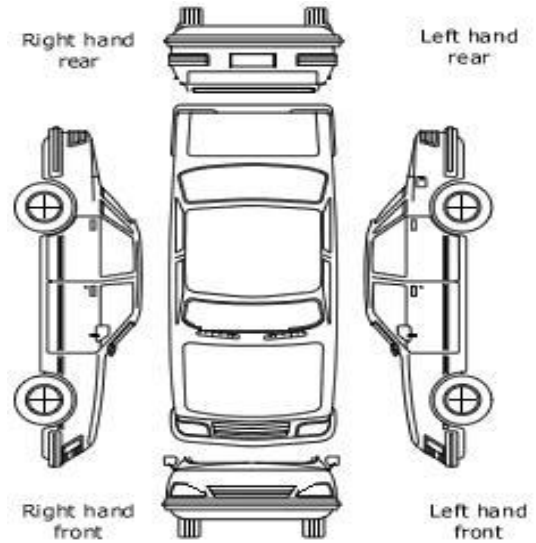
Rust is evident on boot lid
 Scratches, stone chips and minor carpark indentations are evident in various areas.
 Poor paint and panel repairs are evident in various areas.
 Condition of paint is poor

Vehicle Cleanliness:	Fair
Overall Body Condition:	Poor
